MARYLAND INVENTORY OF HISTORIC PROPERTIES HISTORIC BRIDGE INVENTORY MARYLAND STATE HIGHWAY ADMINISTRATION MARYLAND HISTORICAL TRUST

NAME AND SHA NO.: 10071

LOCATION
Road Name and Number: MD 17 over Middle Creek City/Town: Myersville vicinity
County: <u>Frederick</u>
Ownership: X State County Municipal Other
Bridge projects over: _ Road _ Railway X Water _ Land
Is bridge located within designated district?: _ yes _X no NR listed district _ NR determined eligible district locally designated _ other Name of District _
BRIDGE TYPE
Timber Bridge Beam Bridge Truss-Covered Trestle Timber-and-Concrete
Stone Arch Bridge
Metal Truss Bridge
Moveable Bridge Swing Bascule Single Leaf Bascule Multiple Leaf Vertical Lift Retractile Pontoon
Metal Girder Rolled Girder Rolled Girder Concrete Encased Plate Girder Plate Girder Concrete Encased
Metal Suspension
_ Metal Arch
_ Metal Cantilever
X Concrete _ Concrete Arch _ Concrete Slab X Concrete Beam _ Rigid Frame _ Other Type Name

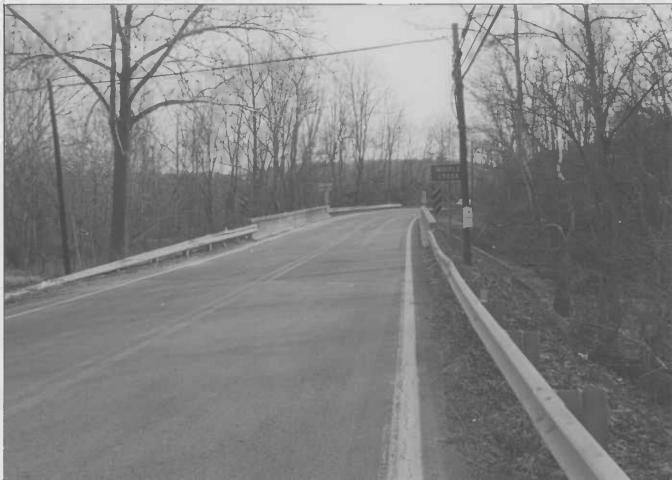
Inventory $\# \frac{1}{2} - 4 - 104$

Name 10071- MO 17 OVER MIDDLE CREEK COUNTY/State FREDERICK COUNTY/MO Name of Photographer FRANK JULIANO Date 295
Location of Negative SHA
Description APPRUACH SOUTH
Number <u>5 of 34</u> 4

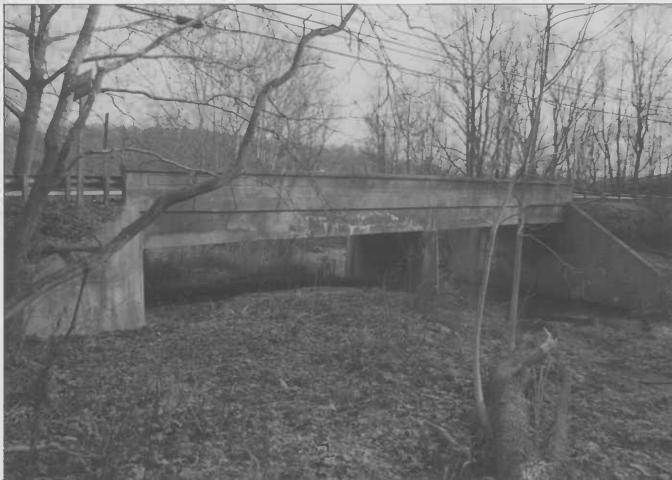
Inventory #<u>F-4-104</u>

Name 1007 - MD 17 County/State FREDE Name of Photographer Date 295	RICK O.	DINITY	
•			
Location of Negative _			
Description ELEVA	TION	LOOKING 1	EAST
Number 4 of 34	4

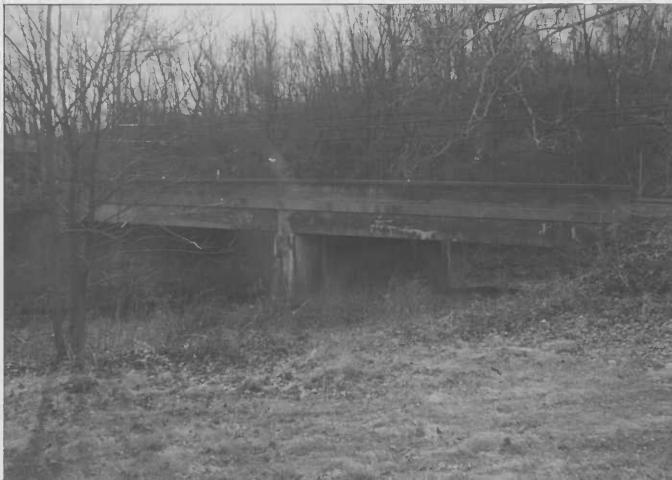
Inventory	#	F	4	-1	04
-----------	---	---	---	----	----

Name 10071 - MD 17 OVER MIDDLE CREEK
County/State FREDERICK COUNTY/MD
Name of Photographer FRANK JULIANO
Date 295
Location of Negative SHA
Description ELEVATION LOOKING WEST
Number 7 of 364

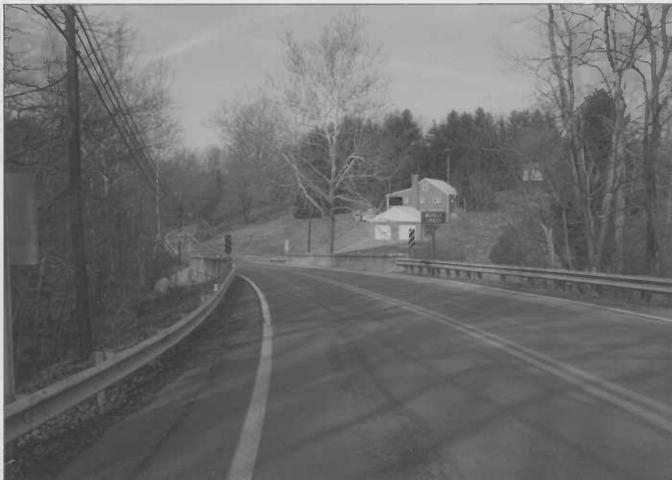
Inventory # <u>F- 4-104</u>

Name 10071-MD17 OVER MIDDLE CREEK
County/State KREDERICK COUNTY IMD
Name of Photographer PRANK JULIANO
Date 295
Location of Negative SHA
Description APPROACH NORTH
Description Arracion 1
Number 2 of 364
